**GREATER JOHNSTOWN WATER AUTHORITY DAM
(SALT LICK DAM)**

**PHASE I INSPECTION REPORT
NATIONAL DAM SAFETY PROGRAM**

PHASE 1 INSPECTION REPORT
NATIONAL DAM SAFETY PROGRAM
GREATER JOHNSTOWN WATER AUTHORITY-SALT LICK DAM
ID NO. PA 429 (PA 11-8)

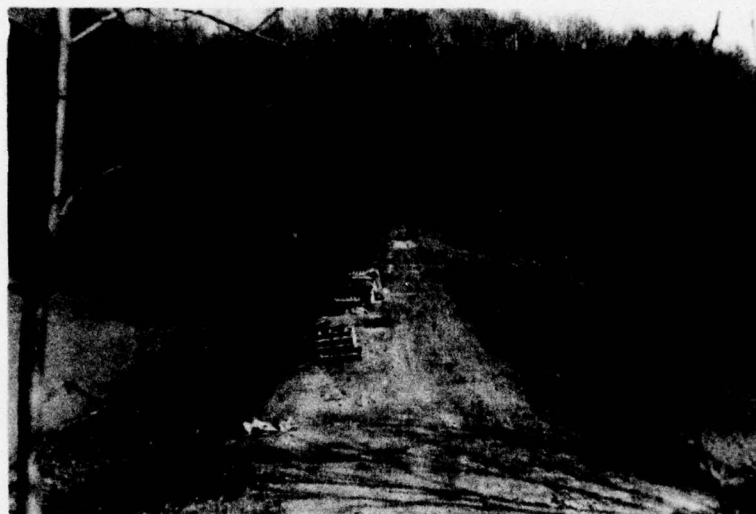
VIEW OF TOP OF DAM, LOOKING SOUTHEAST

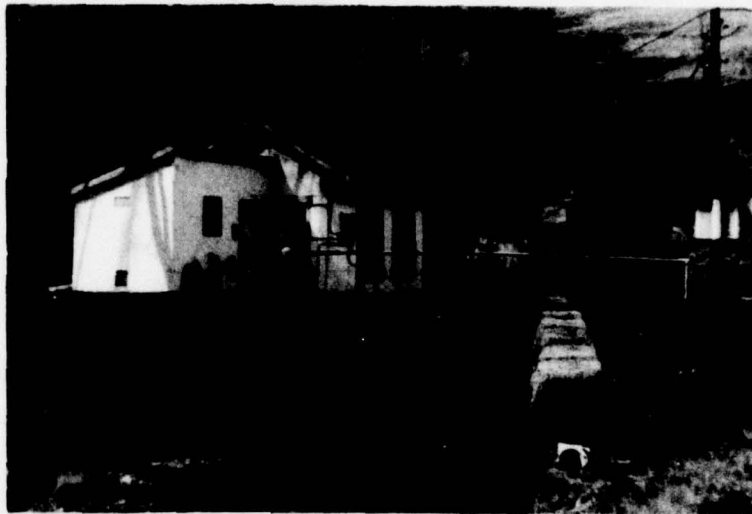
(4) The concrete retaining wall at the outlet end of the access conduit is badly spalled and in need of repairs. The stone masonry wall against the right abutment is bulging and ready to fail. The meter and chlorination house is partially blocking this outlet channel.

VIEW OF CONTROL HOUSE AND DAM CONDUIT

(3) The Owner initiate a program to make the minor repairs to the end of the weir and the walls of the conduit outlet channel, and improve the flow characteristics of said outlet channel around the meter and chlorination building.
